# **Building Inspection Report**

## **Admiralty Club Condominium**

July 5, 2023

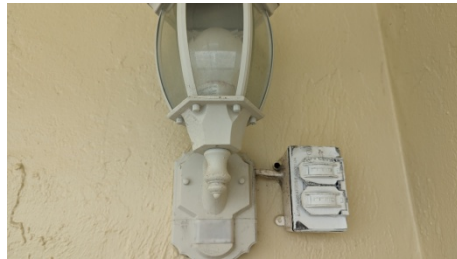
- **Repair, Safety Issue:** Improperly wired outlet(s) were observed on some balconies and should be investigated by a qualified electrician and repaired as necessary.

Improperly Wired

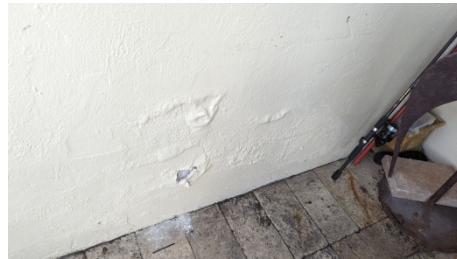
- **Improve, Repair:** Paint bubbles were observed in some areas, but trapped moisture was not observed. There does not appear to be damage behind the paint in most spots, though this makes this area vulnerable to moisture. At this point, I recommend paint repair to prevent water infiltration and protect the building envelope.
- **Repair:** There is ongoing repair/replacement of railings in effect.

Paint Bubbles

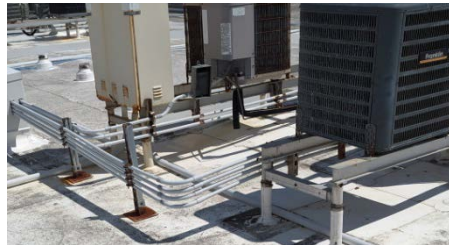
- **Monitor/Maintenance:** Corroded A/C anchors should be replaced before failure occurs
- **Improve:** There was a broken electrical box and exposed wires
- **Monitor:** Roof drains might require cleaning. This may help with the pooling taking place in these areas.

Corrosion on Anchors

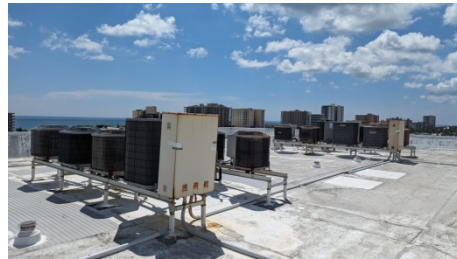
Individual Unit Systems

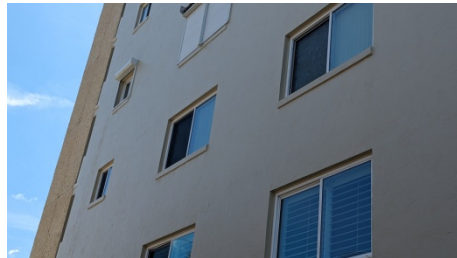
Windows Good Condition

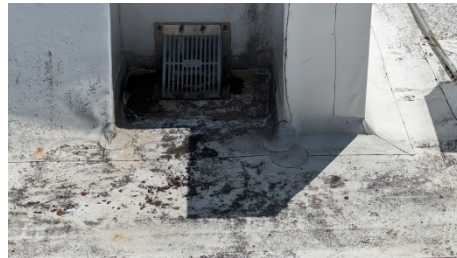
Maintenance Rooftop Drains
