# Structural Integrity Reserve Study

## Admiralty Club Condominium

July 5, 2023

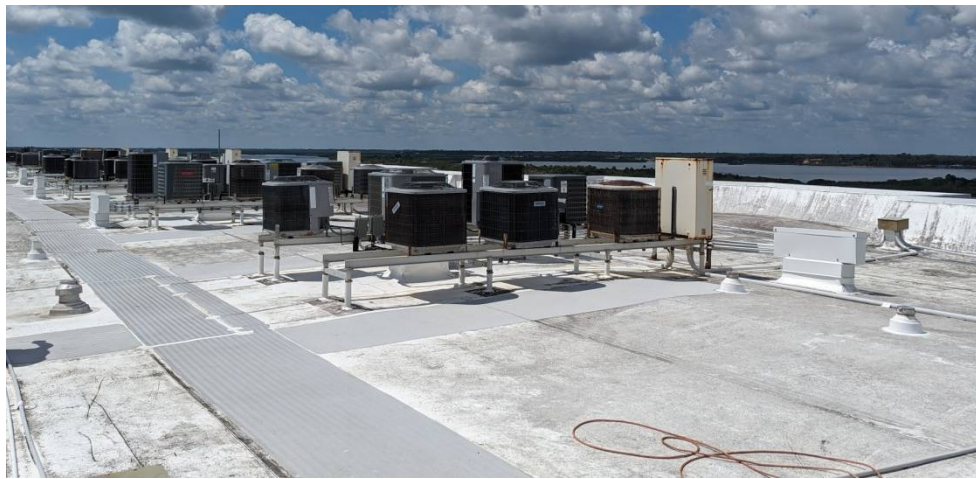
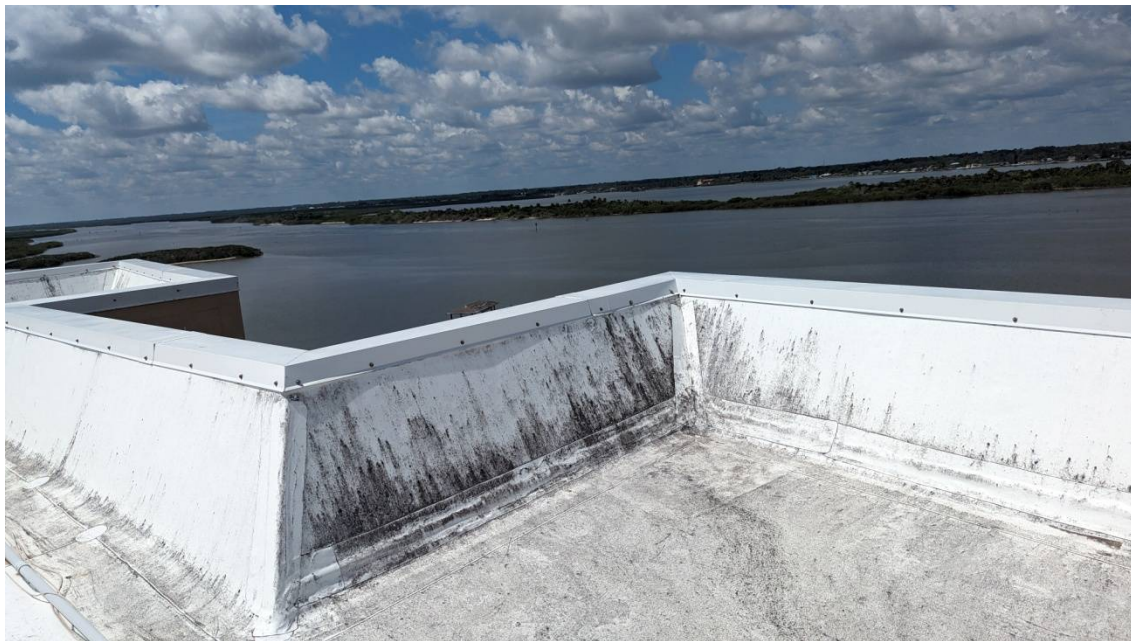
## Roof

- Component Condition: Good
- Observations: The roofing system consists of a thermoplastic polyolefin (TPO) flat roofing membrane with parapet walls at the perimeter, metal coping and metal flashings. The roof has a remaining useful life of approximately 20 years.
- Recommendations: To maintain the quality of the structure, replace the roof in 20 years upon reaching the end of its useful life. Fix or replace rusted AC stands and anchors, damaged metal flashings, and coping. Maintain regular inspection and clean roof drains to ensure longevity.

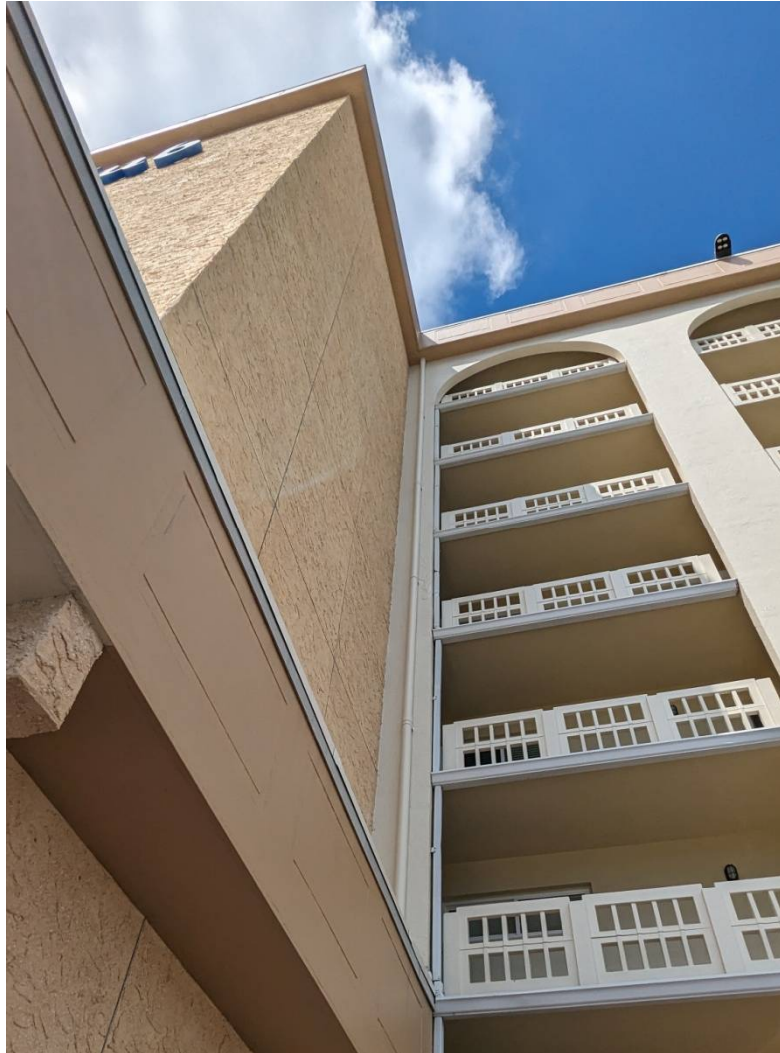
## WALKWAYS

- Component Condition: Good
- Observations: The walkways appear to be in good condition. The walkways are concrete on all floors.
- Recommendations: Repair cracks and spalls in the walkways beams. Regularly inspect railing posts.

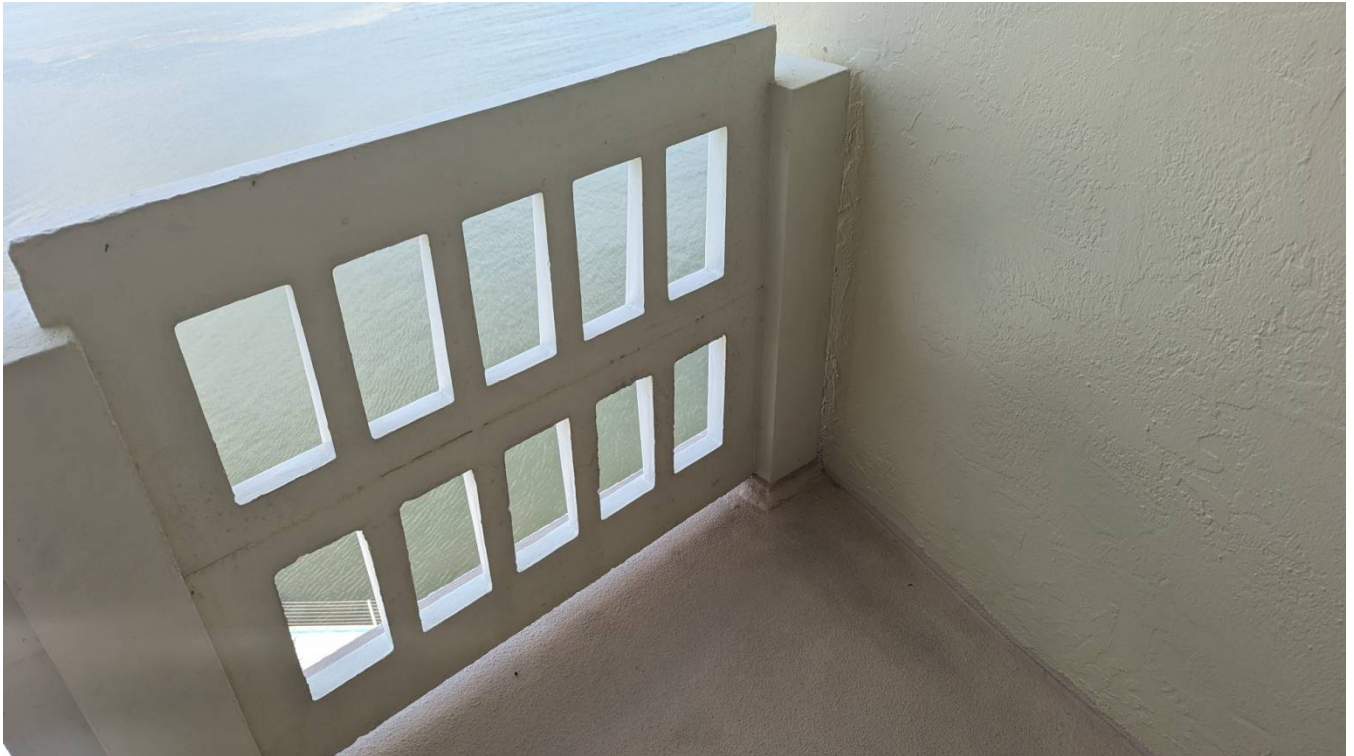
## BALCONIES

- Component Condition: Good
- Observations: The balconies appear to be in generally good condition. A balcony inspection was performed in conjunction with the SIRS visual inspection. Sounding tests were conducted and some areas indicating delamination, spalling, and cracking were identified.
- Recommendations: Repair cracks and delamination of stucco. Fill holes and repair patches where coating/waterproofing is missing to reduce moisture intrusion.

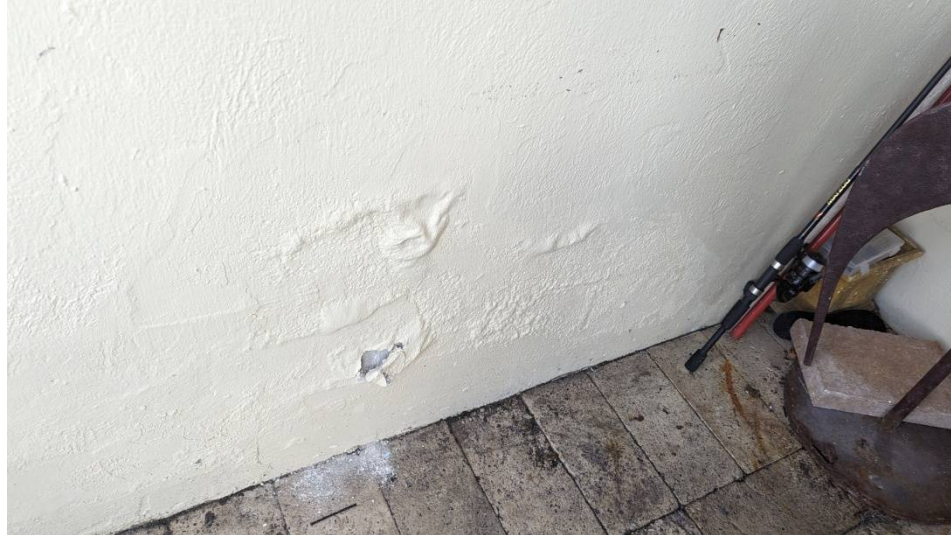
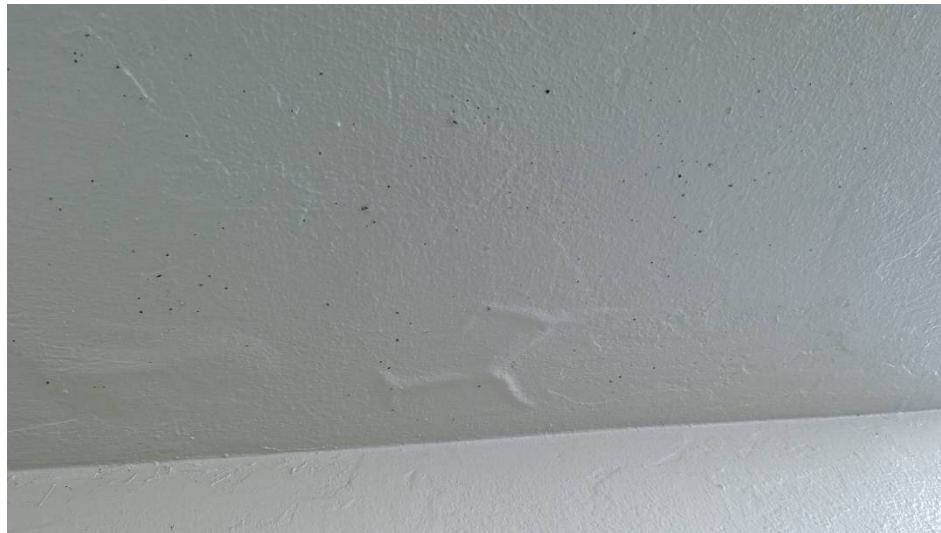
# Waterproofing and Exterior Painting

- Component Condition: Good
- Observations: The exterior painting and stucco of the building are in generally good condition. Paint bubbles were observed in some areas. There does not appear to be damage behind the paint in post spots, though this makes the area vulnerable to moisture.
- Recommendations: Repair paint to prevent water infiltration and protect the building envelope.

- **Exterior:** The building's exterior paint and waterproofing are generally in good shape, though some areas with bubbling paint need attention to prevent water intrusion.

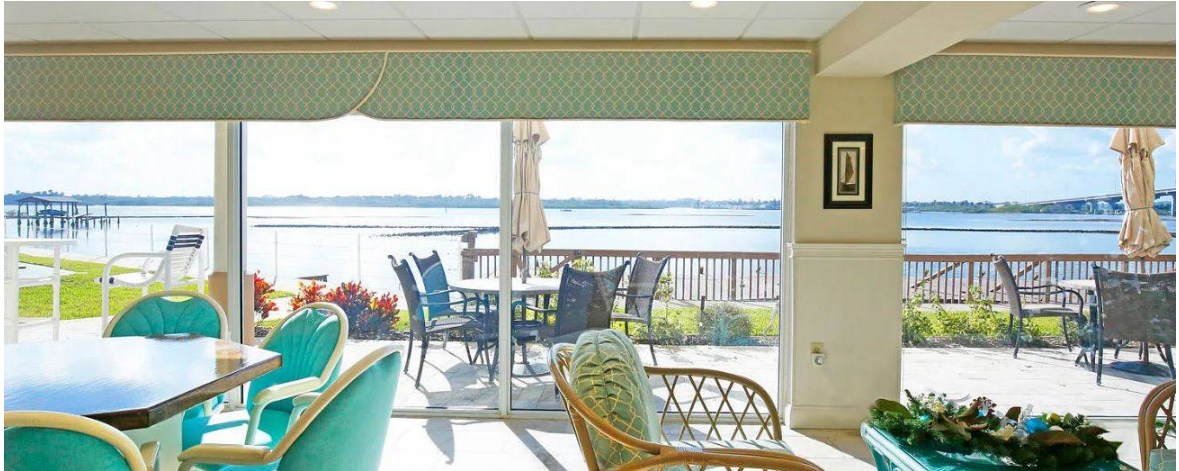
## WINDOWS (COMMON)

- Component Condition: Good
- Observations: Windows are in good condition, installed 2017
- Recommendations: Regularly inspect for signs of water intrusion

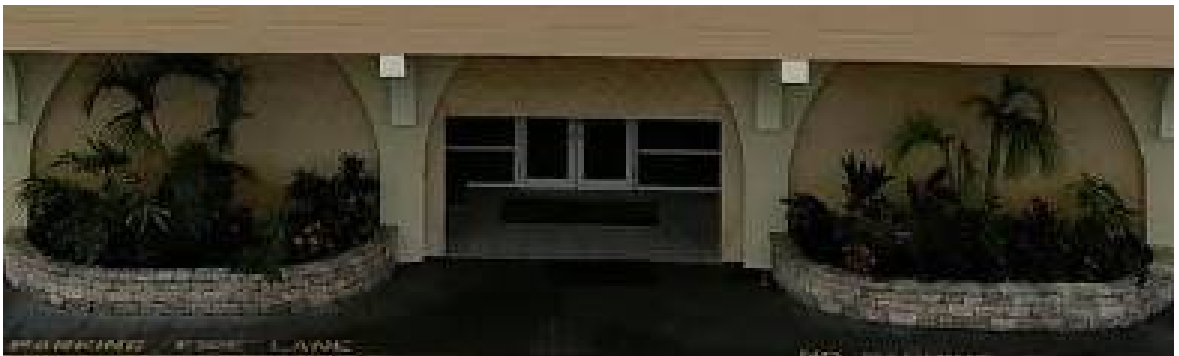
## DOORS (COMMON)

- Component Condition: Good
- Observations: Replaced 2020
- Recommendations: Regularly inspect for signs of water intrusion
